First Five Year Review Report

Powell Road Landfill Site

Huber Heights

August 2003

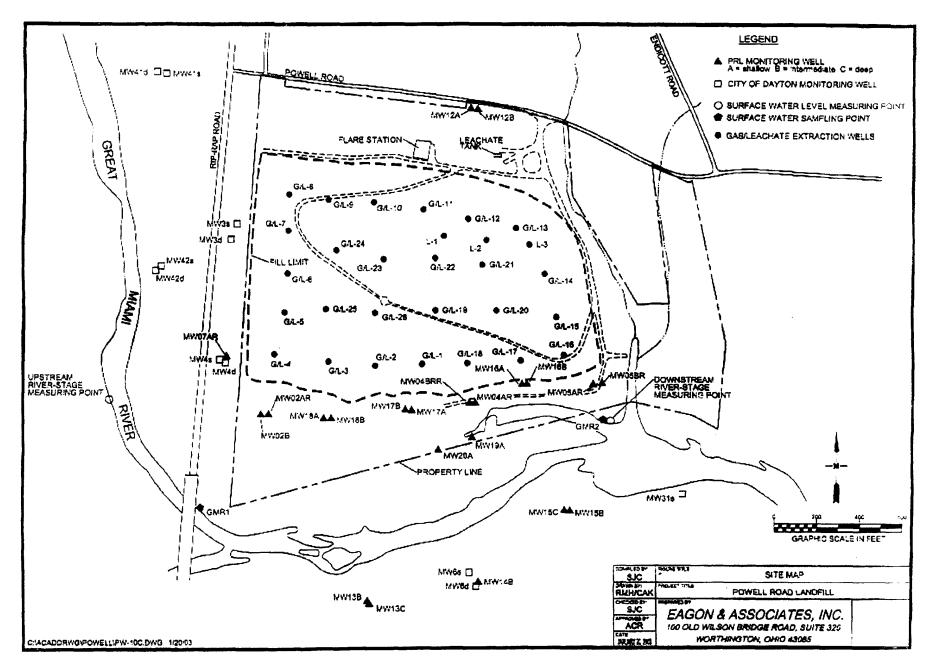
FIGURE 2. SITE MAP

The active landfill gas and leachate extraction systems have been operational since January 2000. The locations of the extraction wells, the leachate collection tank, and flare station are shown on Figure 2. The system consists of 26 dual gas and leachate extraction wells, and three wells constructed for leachate extraction only. The landfill leachate and condensate from the gas extraction system are collected in a 20,000 gallon tank. The leachate is currently being trucked off-site for treatment. Landfill gas is collected under vacuum from the extraction wells and directed to the flare station for thermal treatment. Monitoring wells have been installed to monitor groundwater quality and water levels. The groundwater monitoring wells are shown in Figure 2.

Groundwater Study. The groundwater monitoring wells are shown in Figure 2. Based on water level data, groundwater flow in the shallow zone and primary aquifer is primarily to the south. During high flow conditions in the Great Miami River, groundwater flow shifts slightly to the southeast. For the most part, VOC data collected since the RI show a decrease in contamination in the shallow groundwater zone as well as a reduction in the number of compounds detected and in the concentrations of individual compounds. There is no evidence of contaminant migration from the shallow zone to the primary aquifer or to the south of the Great Miami River. Contaminant concentrations in the primary aquifer in the vicinity of the Site are at low levels. Groundwater monitoring continues to indicate hat the plume is dissipating.
